Manhole Inspection Summary

Manhole # S21M__036MH

Insp Date: **2/25/09 9:38 AM**

Location Address: **518 MONROE-ADDISON-ALLEY**

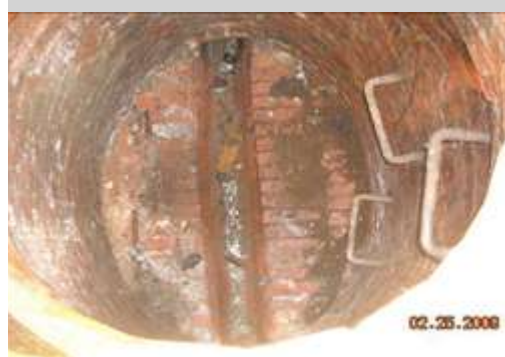
Top View

Comments **BROKE AND REPLACED COVER (see photos); POSSIBLE POINT OF ENTRY FOR
AUTOMOTIVE RUN OFF FROM ADDRESS 501 S MONROE ST**
